Limited Visual Dam Safety Inspection Summary Report

MA-097

Kolea Reservoir

Limited Visual Dam Safety Inspection Conducted on: 05 April 2006

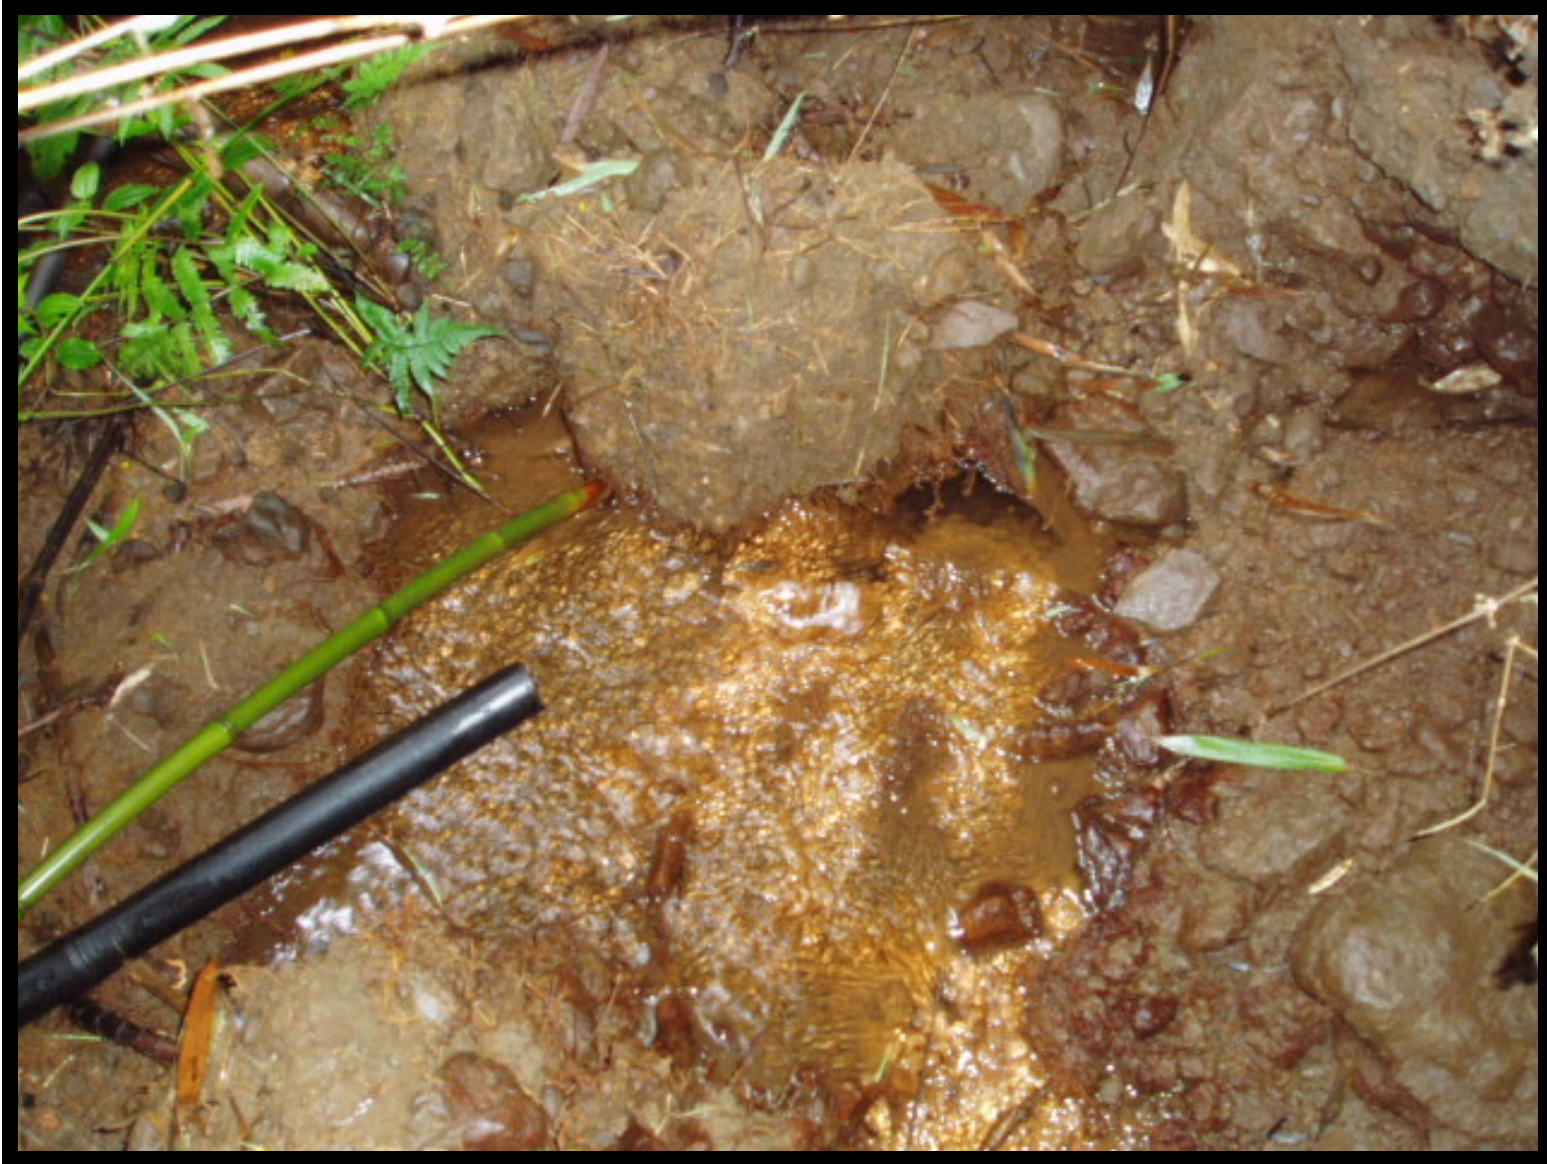
Seepage was observed in the outlet channel at a distance of about 10 feet from the outlet conduit. The seepage was flowing clear at a rate of approximately 20-gpm.

097 seep - View of the seep located about 10 feet downstream of the outlet pipe in the exit channel. Owner should routinely monitor the seep for change in flowrate or condition.

- b. Seepage/Ponding water was observed. Monitor and conduct further investigation to locate the source of water and extent of any possible hazardous or developing condition.
- c. Monitor the seep below outlet pipe for change in flowrate or condition (i.e., seep moving soil).

- 1) Monitor the seep just below the outlet pipe in the exit channel. Monitor the seep for changes in flowrate or condition (i.e., seep moving foundation material). Owner should have a geotechnical engineer, knowledgeable in the evaluation, design, and construction of dams; conduct a detailed evaluation of the seepage conditions.
- 2) Owner needs to routinely remove underbrush and bamboo from the downstream slope. Bamboo should be cut and removed at least twice a year or sprayed with herbicide and removed.
- 3) The owner should continue with removing brush and trees from the embankment. Grasses should be kept short.

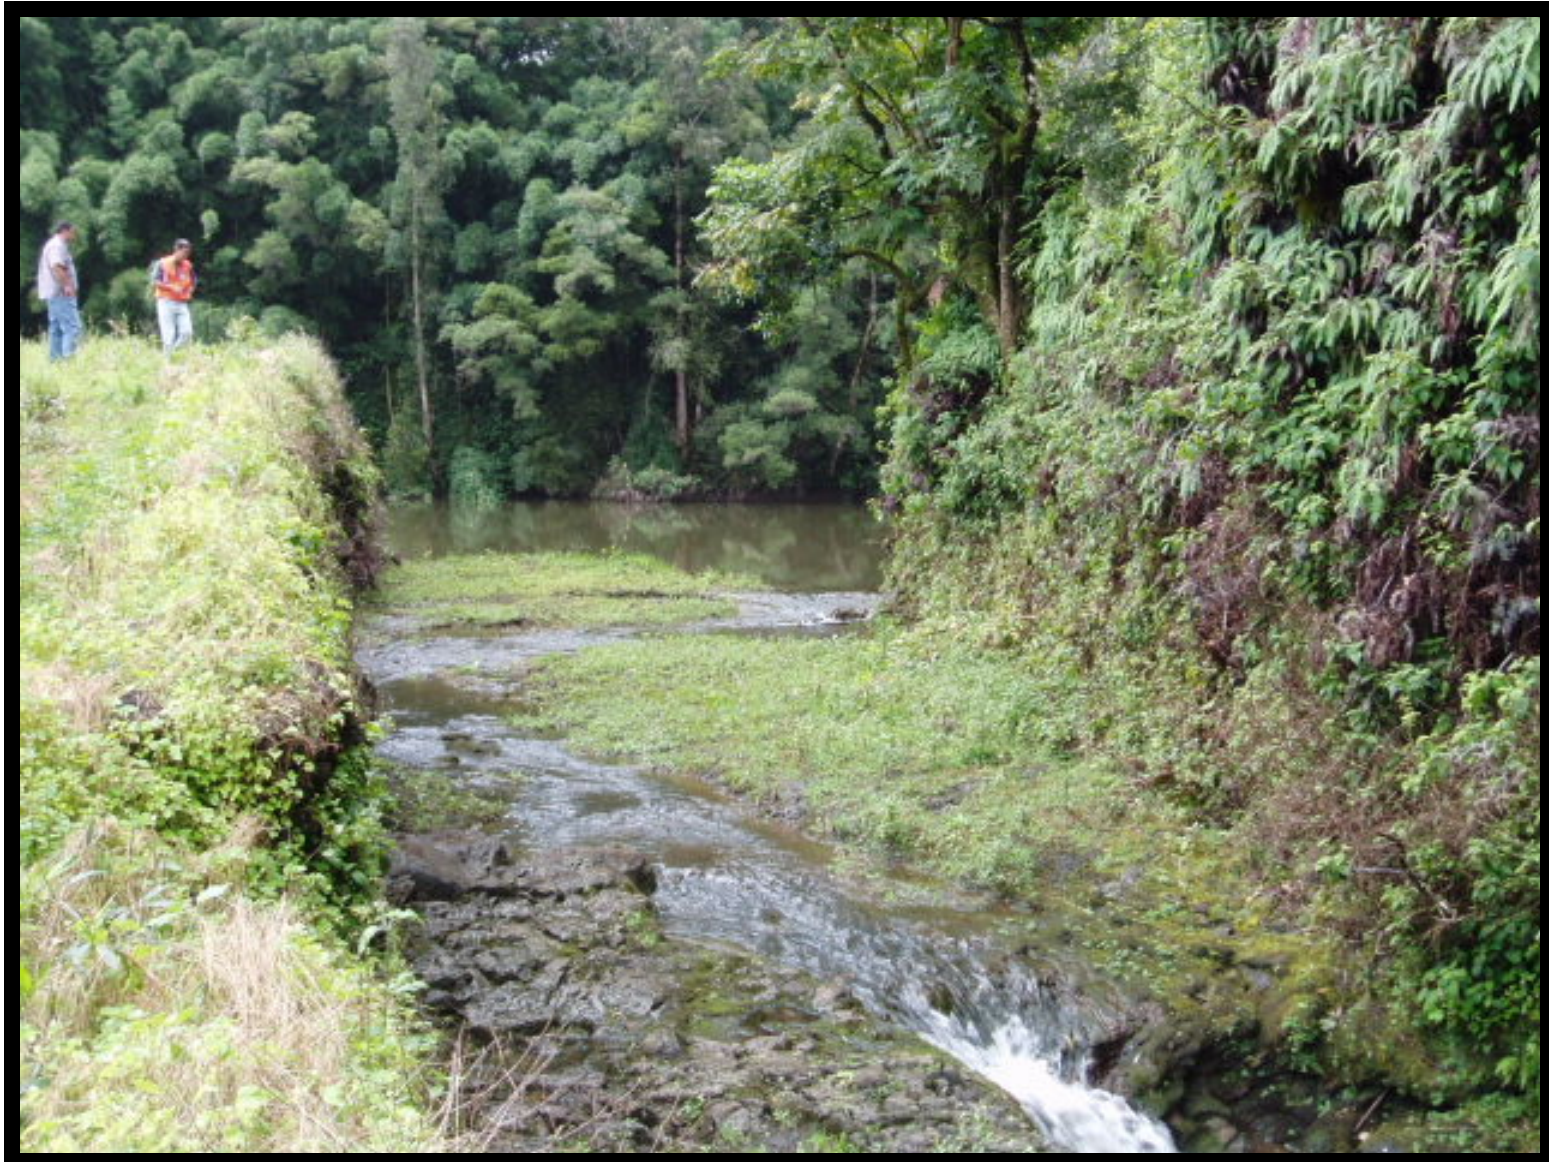
The spillway approach was clear.

Erosion was not observed at the time of inspection.

- a. The Spillway appeared to be in satisfactory condition, no corrective actions are required at this time.

097 Spillway. The spillway was slightly flowing during the inspection. The reservoir is full.

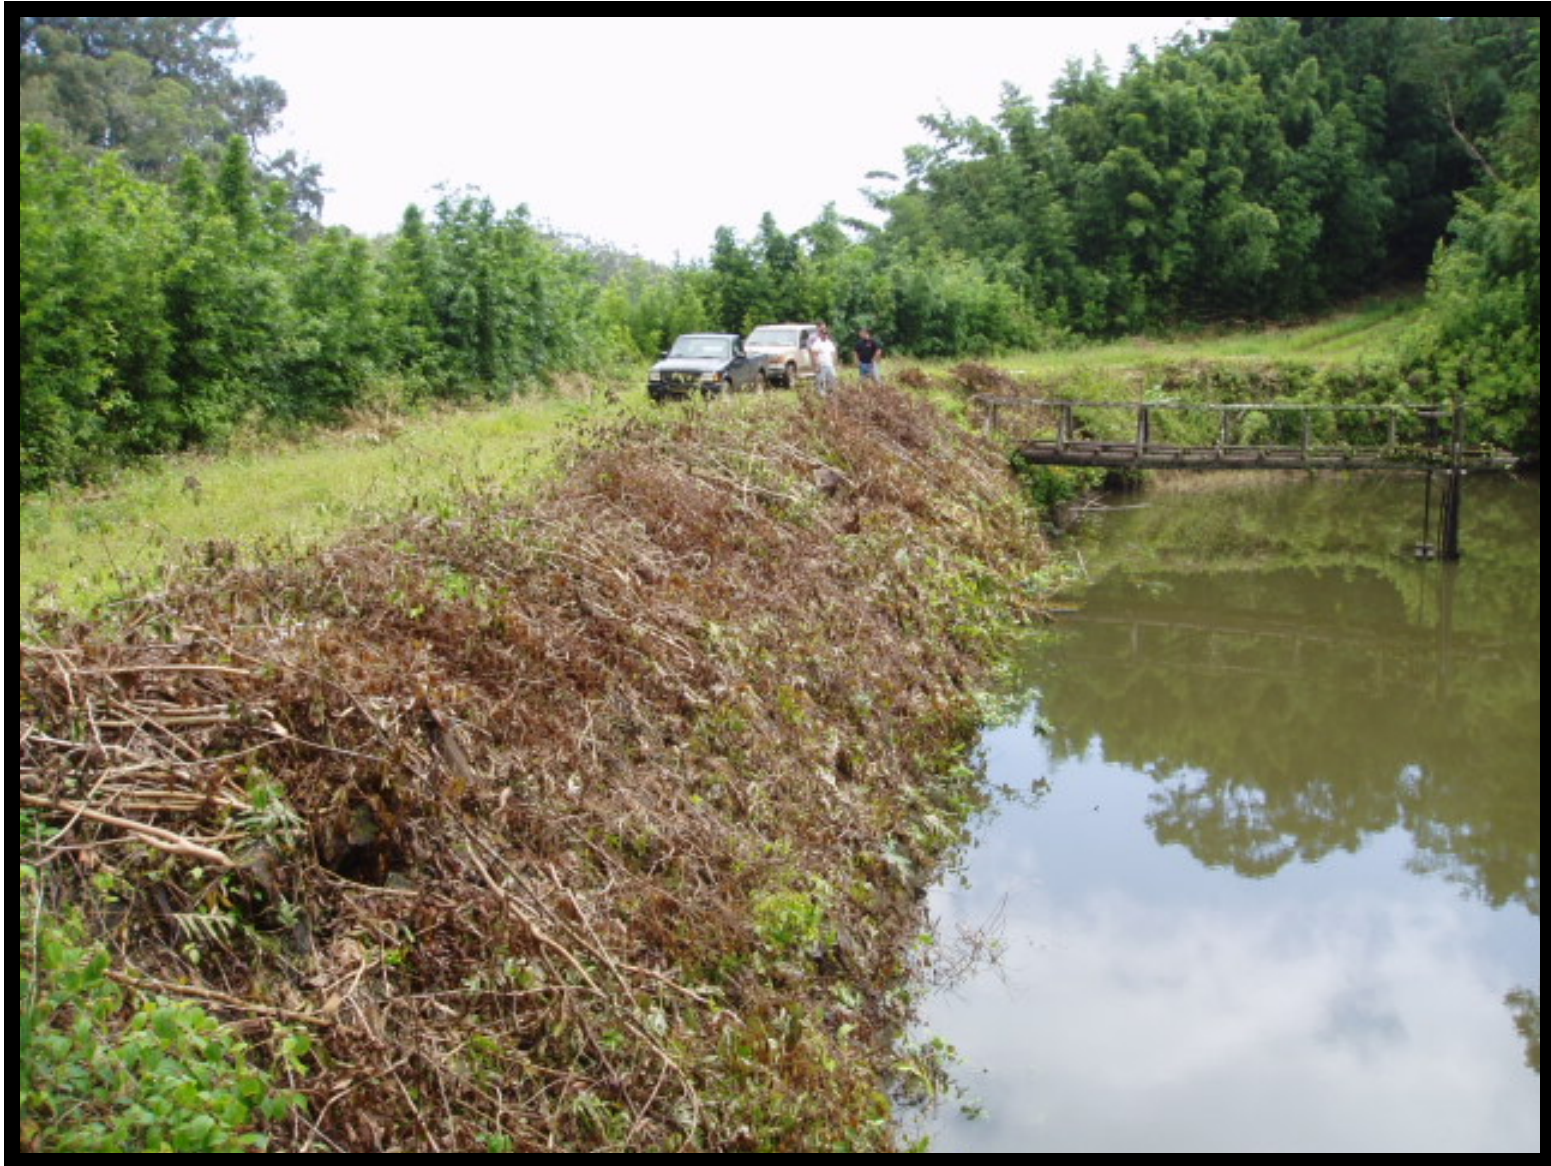
The upstream slope is protected by dumped rock.

Erosion on the upstream slope was not observed at the time of inspection.

The brush on the slope has been recently cut.

- a. The upstream slope appeared to be in satisfactory condition, no corrective actions are required at this time.

097 upstream - Upstream slope of the dam. Note recently cut brush on the slope.
